Mitigation Assessment Team Report

Hurricane Ike in Texas and Louisiana

Building Performance Observations, Recommendations, and Technical Guidance

FEMA P-757 / April 2009

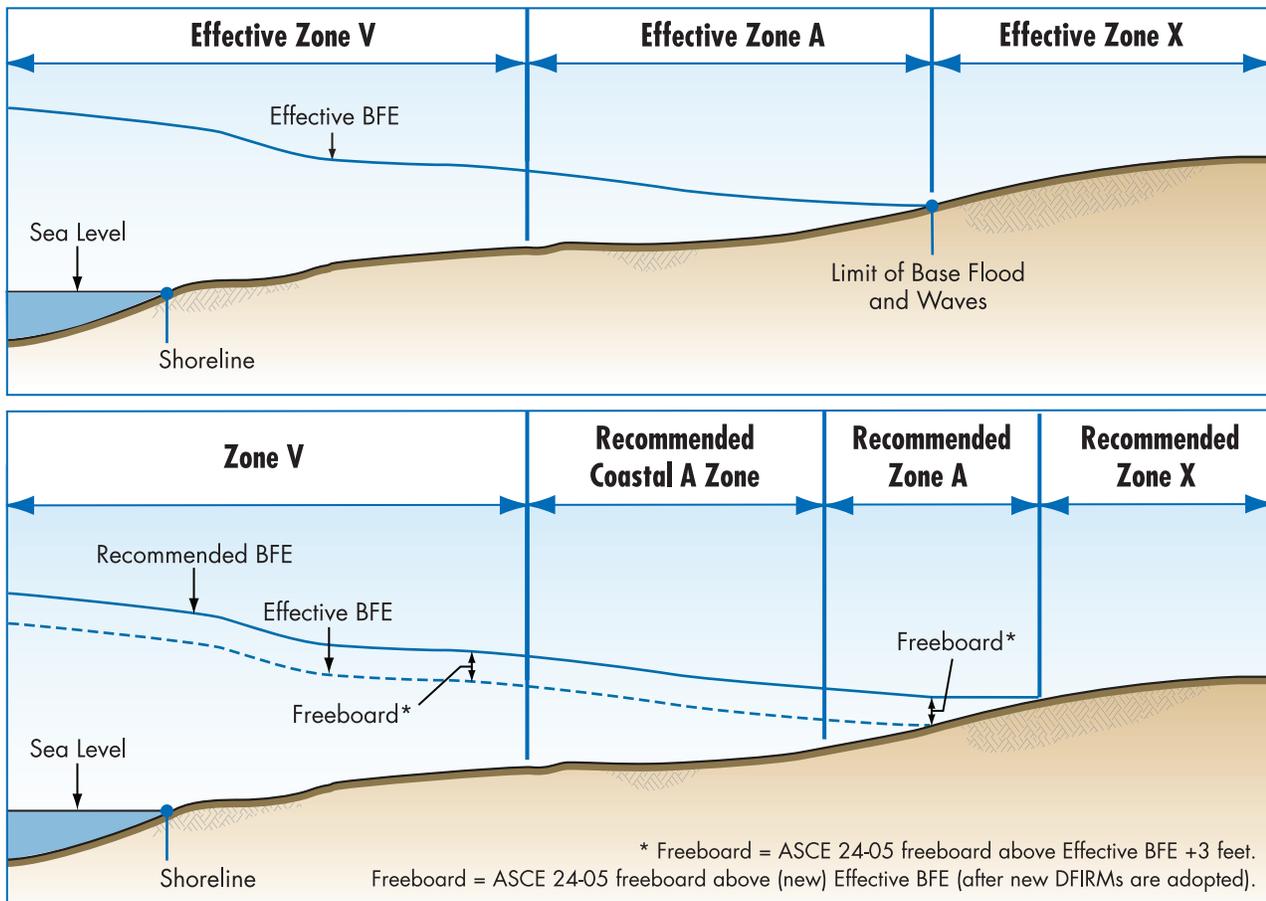
Figure ES-1. Comparison of Effective BFEs and flood hazard zones (upper figure), with MAT-recommended freeboard and flood hazard zones (lower figure)

- f. All new and replacement manufactured homes should be elevated to or above the BFE using wind- and flood-resistant foundations, such as those specified in the National Fire Protection Association 225-09, and installation of new manufactured homes should follow the guidance provided in FEMA 85, *Manufactured Home Installation in Flood Hazard Areas* (1985). (Note that FEMA 85 is currently under revision and is tentatively scheduled for release later in 2009.)

Figure ES-1 illustrates the recommendations outlined in bullets a, b, and c above.
